Super Salvage, Inc.
Industrial Stormwater Inspection Report

Appendix B

Photograph Log and Photographs

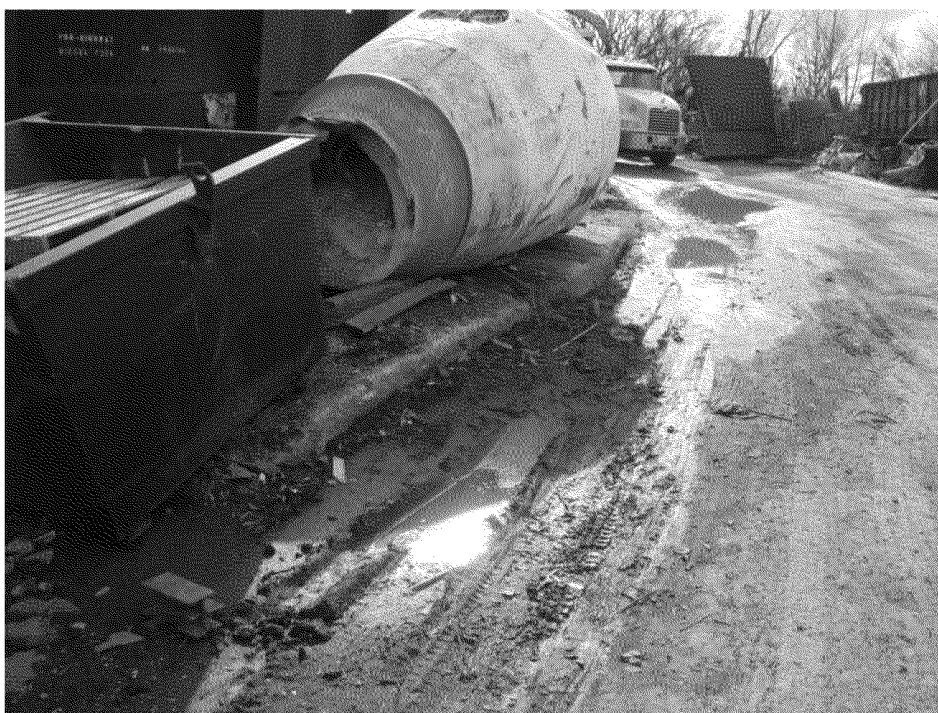
Photograph 58. Storage of debris outside the perimeter of the facility adjacent to the DC property .
